DEPARTMENT OF TRANSPORTATION**DIVISION OF ENGINEERING SERVICES**

Contract #: 04-0120F4Cty: SF/ALA Rte: 80 PM: 13.2/13.9File #: 69.28**WELDING INSPECTION REPORT****Resident Engineer:**Pursell, Gary**Address:** 333 Burma Road**City:** Oakland, CA 94607**Report No:** WIR-015270**Date Inspected:** 21-Jun-2010**Project Name:** SAS Superstructure**OSM Arrival Time:** 700**Prime Contractor:** American Bridge/Fluor Enterprises, a JV**OSM Departure Time:** 1900**Contractor:** Zhenhua Port Machinery Company, Ltd (ZPMC), Changxing Island **Location:** Shanghai, China**CWI Name:** Li yang**CWI Present:** Yes No**Inspected CWI report:** Yes No N/A**Rod Oven in Use:** Yes No N/A**Electrode to specification:** Yes No N/A**Weld Procedures Followed:** Yes No N/A**Qualified Welders:** Yes No N/A**Verified Joint Fit-up:** Yes No N/A**Approved Drawings:** Yes No N/A**Approved WPS:** Yes No N/A**Delayed / Cancelled:** Yes No N/A**Bridge No:** 34-0006**Component:** OBG Components**Summary of Items Observed:**

Orthotropic Box Girder (OBG) Trial Assembly Areas

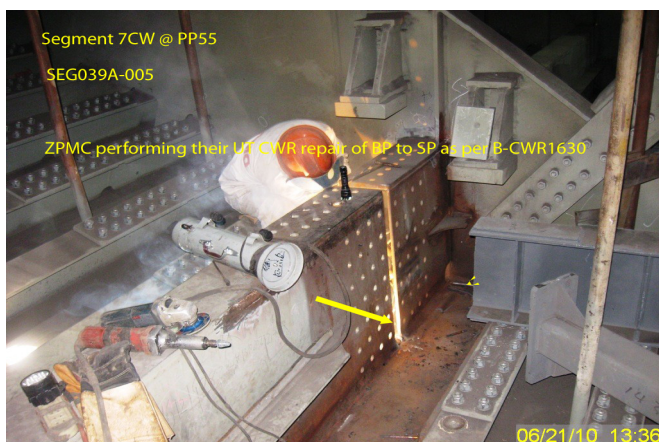
This QA inspector observed ZPMC qualified welding personnel performing Shield Metal Arc Welding (SMAW) welding was performed on repair weld joint 005 located at SEG039A cross beam side segment 7CW @ PP55. Welder number is identified as 045196. ZPMC QC is identified as Zhanghai tao. The welding variables monitored and recorded by the QC appeared to comply with WPS-345-SMAW-1G(1F)-FCM-Repair-1.
